## KEIM SOUTHERN AFRICA CASE STUDY: ZEITZ MOCAA, CAPE TOWN

▼ KEIM CONCRETAL FOR REPAIR & DECORATIONS

# ZEITZ MUSEUM OF CONTEMPORARY AFRICAN ART

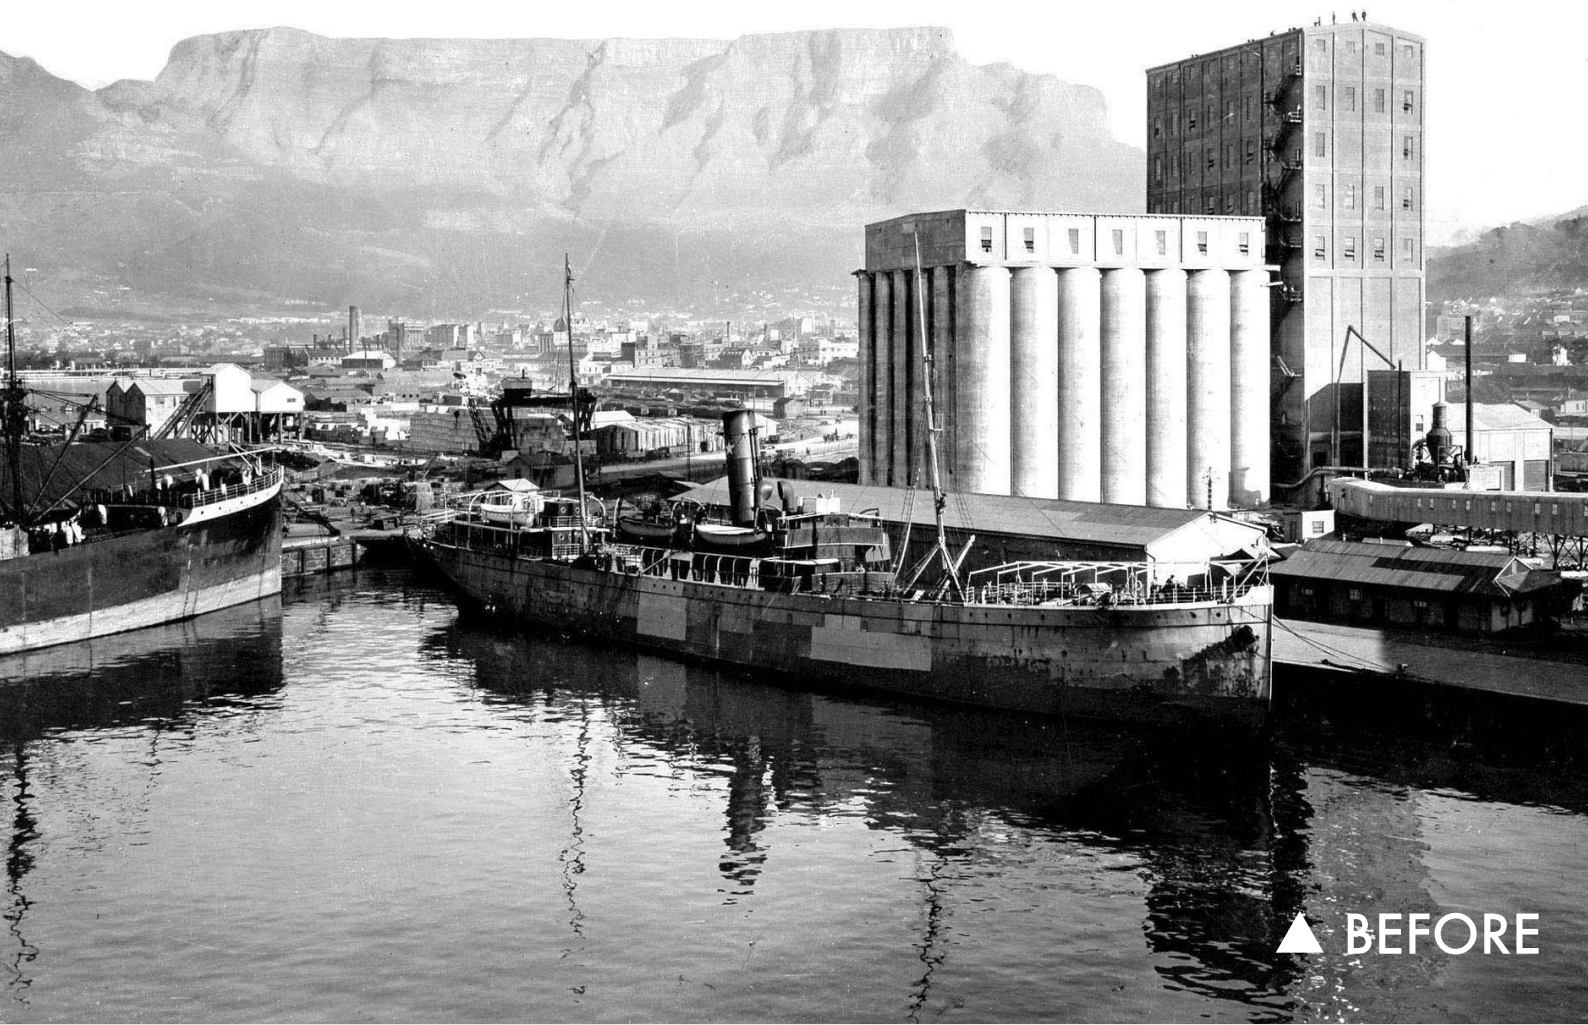
▲ BEFORE

▼ AFTER

The issues were addressed with the use of the KEIM mineral product range, as recommended by the architects. Initially, the surface irregularities were corrected by removing projections, filling recesses, gravel pockets and smaller cavities and levelling defects exceeding four millimetres to create flat surfaces.

Next, the inconsistent material appearance with varying gloss levels was managed. The walls were pre-wetted and any residues from release agents or oily stains were eliminated.

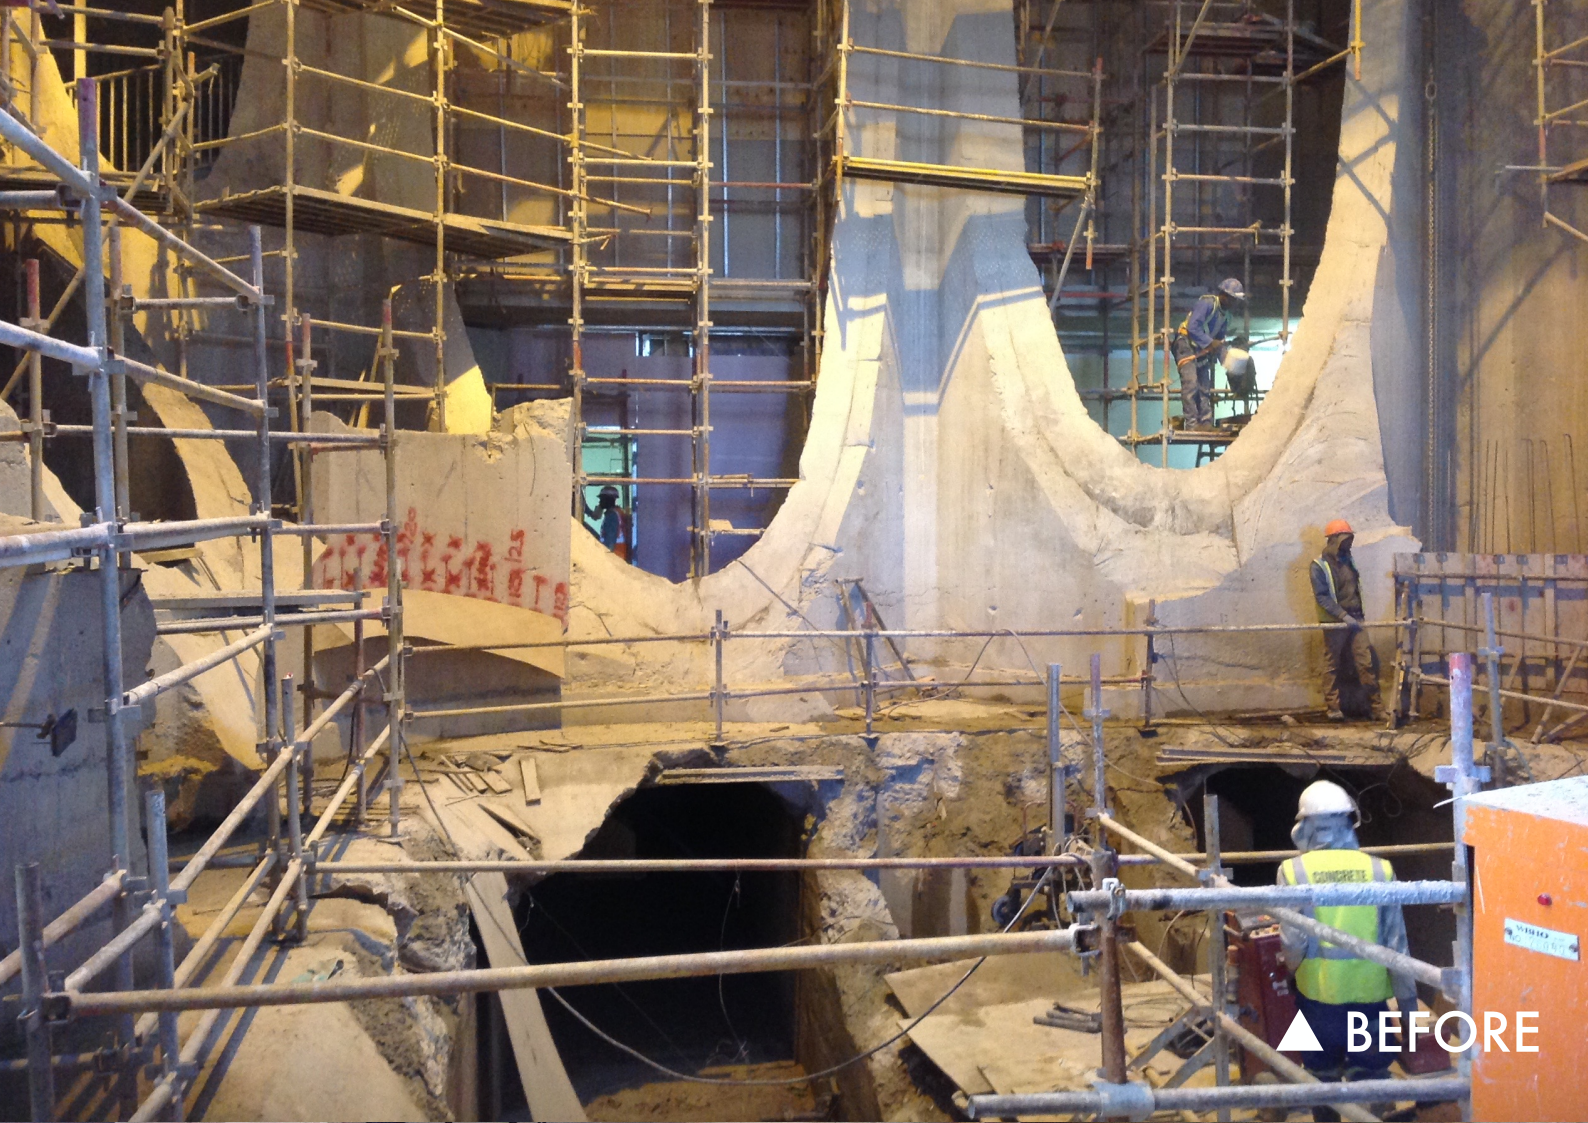
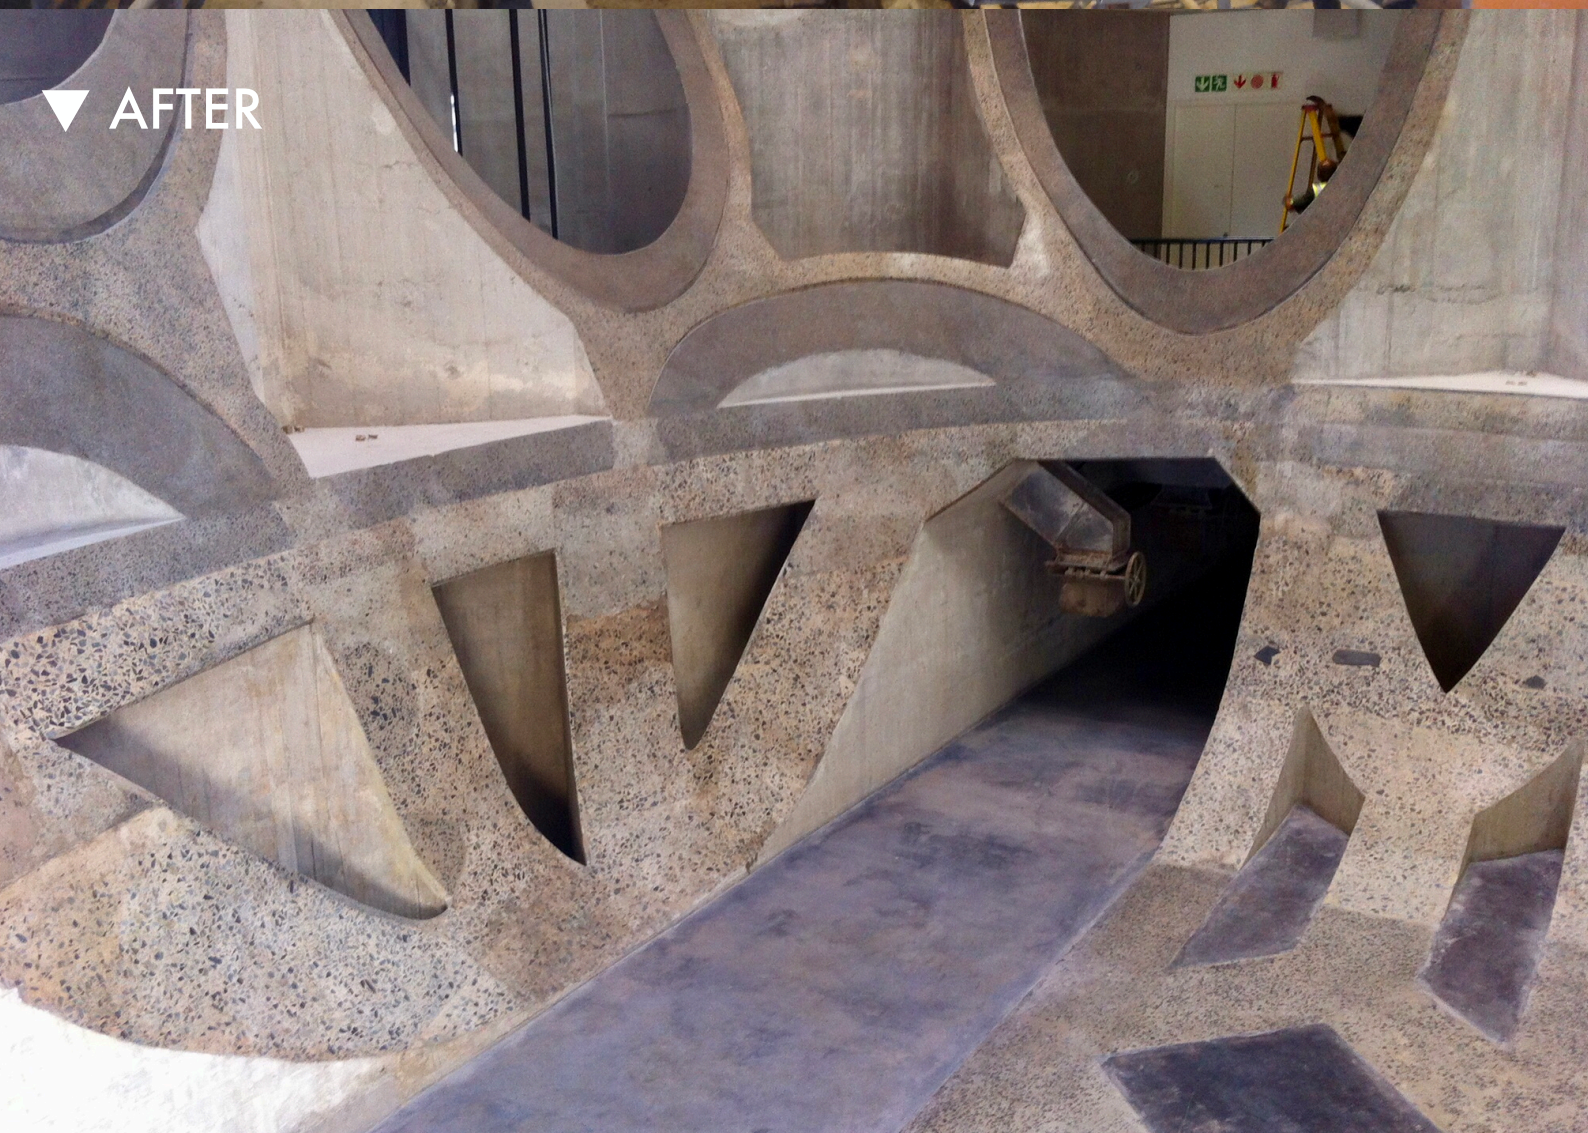
Unsurprisingly, the concrete surfaces required rework upon removal of the formwork. They exhibited numerous defects, including instances where cement glue had leaked, creating pockets of gravel. Additionally, slight slippage of the formwork panels resulted in wall surfaces with projections and recesses ranging from 10 to 40 millimeters. Given that the silo tubes are consistently illuminated by oblique light from above, these irregularities produced pronounced shadows, making them particularly noticeable.

Furthermore, the varying surface qualities of the concrete did not meet the architects' specifications; in some areas, it appeared matte or slightly glossy and it displayed different colour tones in other locations. There were also typical construction marks, such as pencil or chalk lines, oily stains from the formwork and vertical dirt streaks

The "KEIM Concretal-Lasur," a thin-layer glaze also known as a mineral stain, demonstrated its advantages in this application. As a mineral coating, it maintains the visible, open-pored structure of the concrete by not forming a surface film. To achieve an appearance as close as possible to untreated concrete, various sample surfaces were tested.

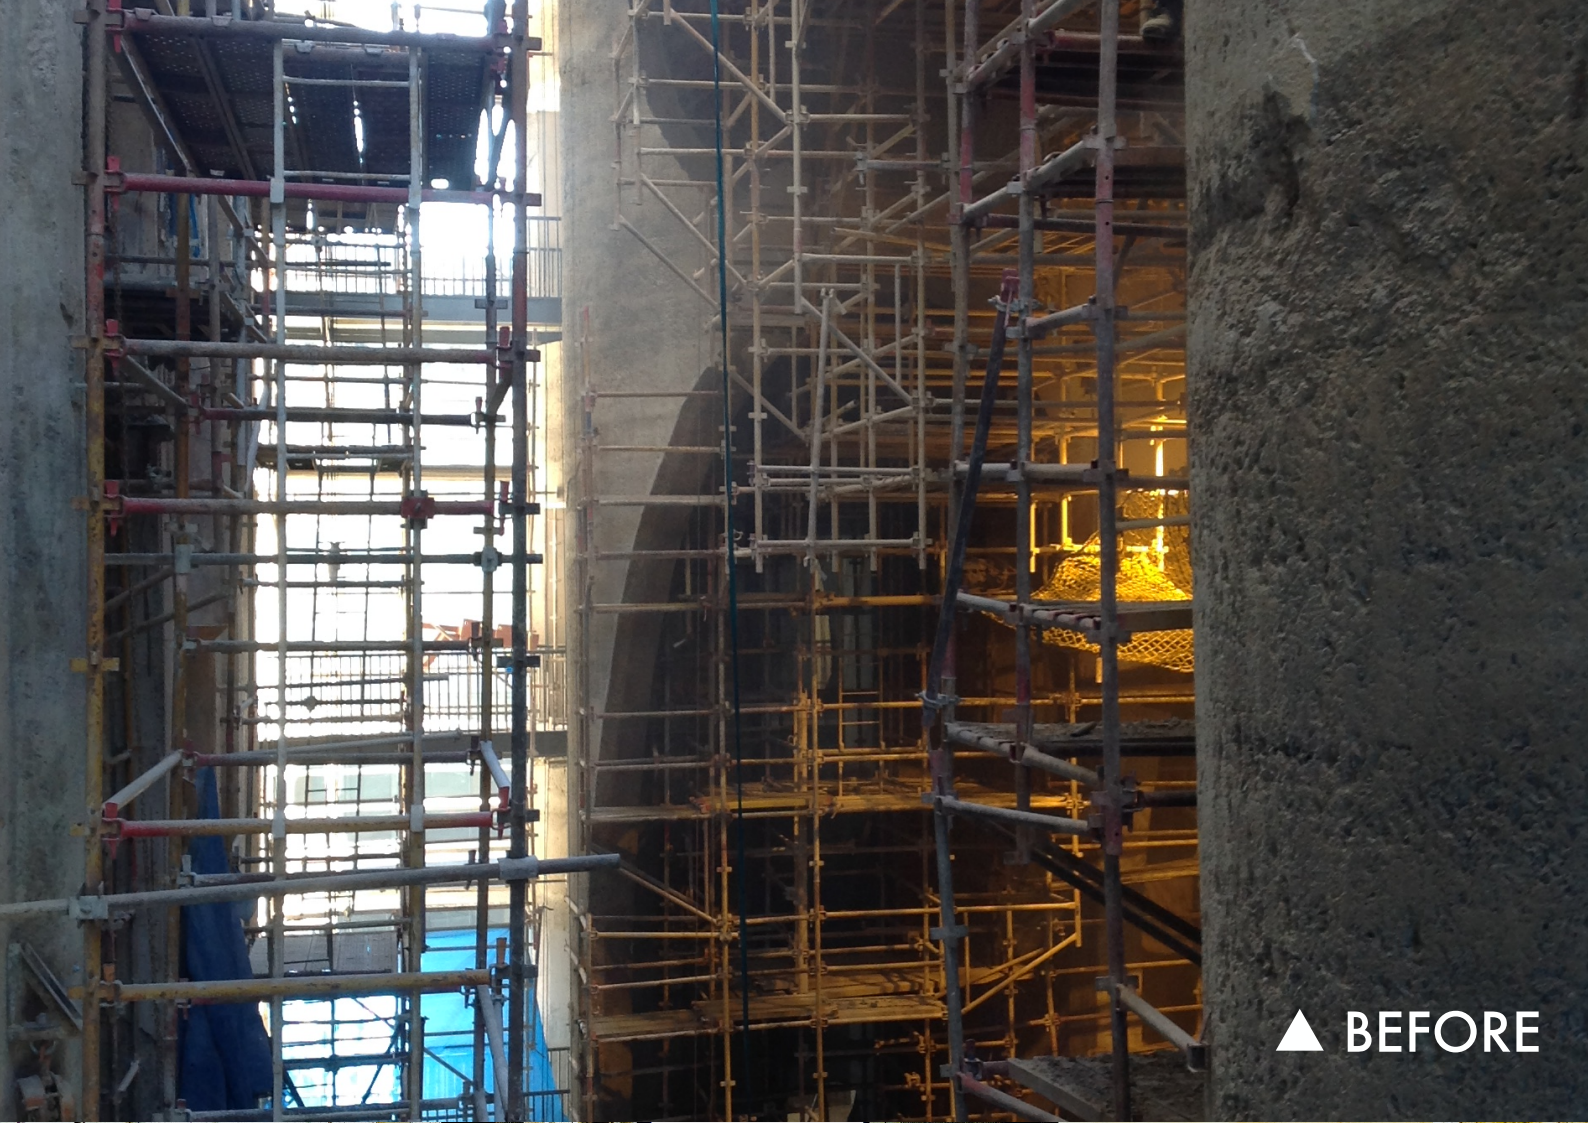
▲ BEFORE

▼ AFTER

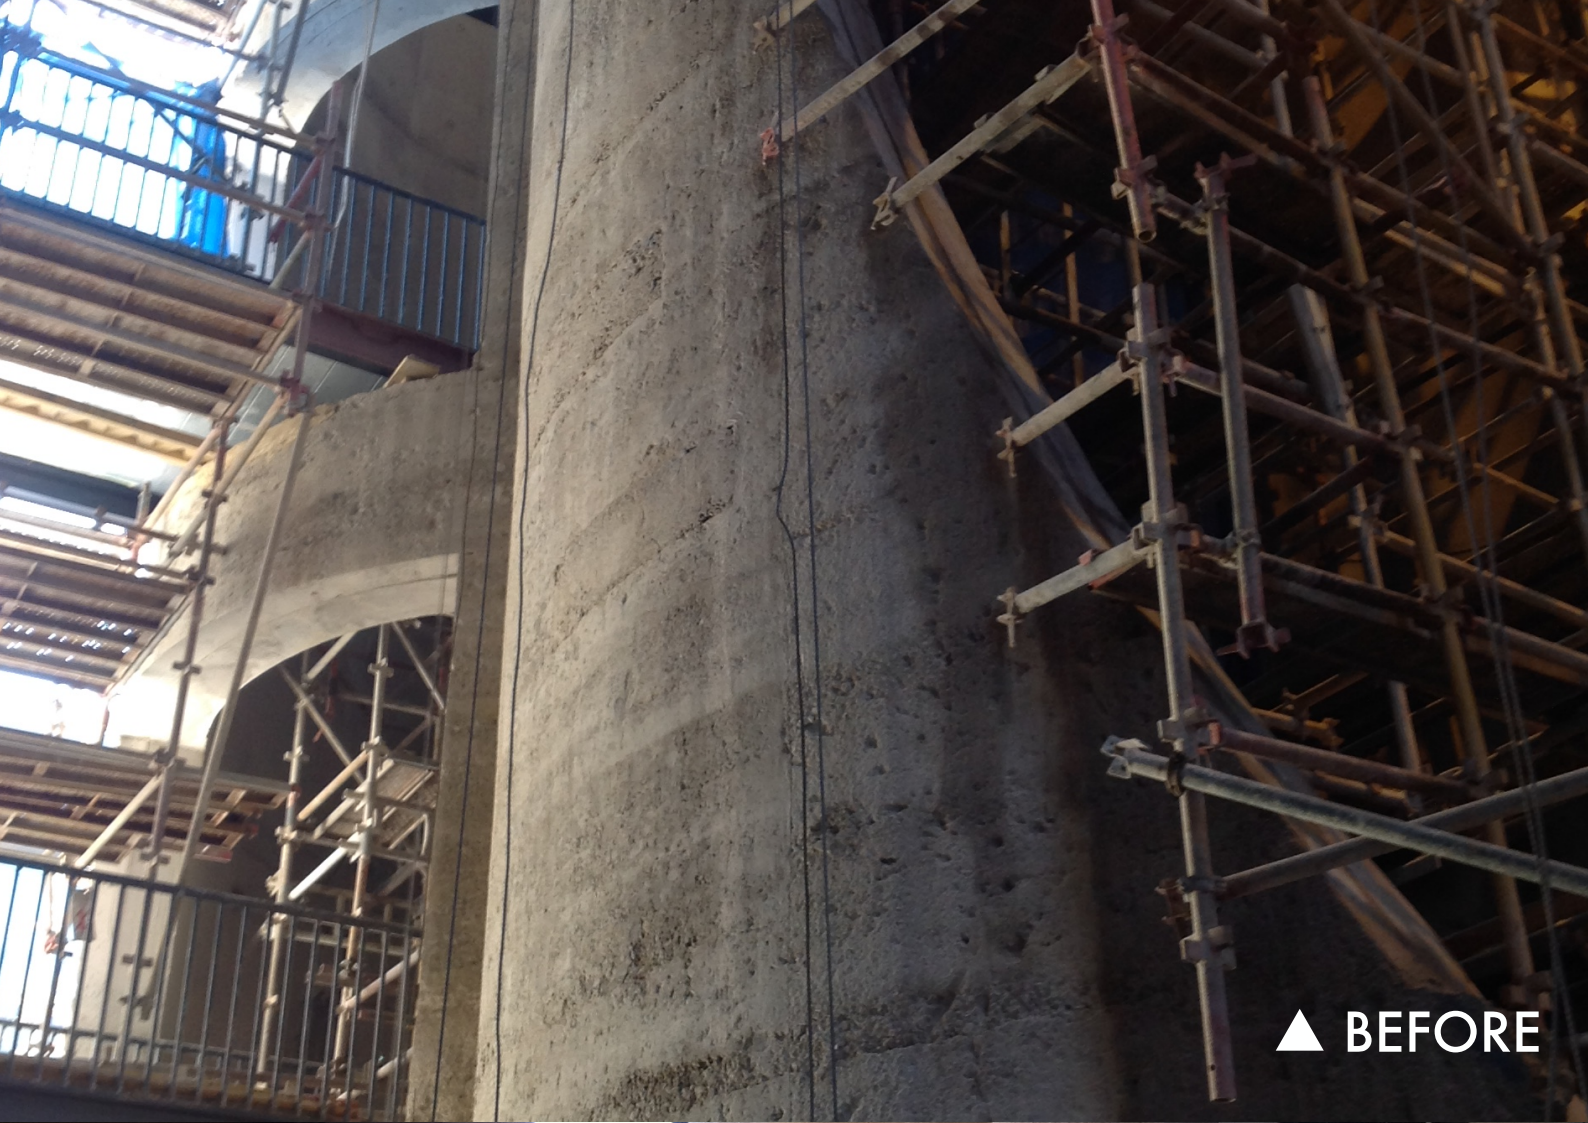
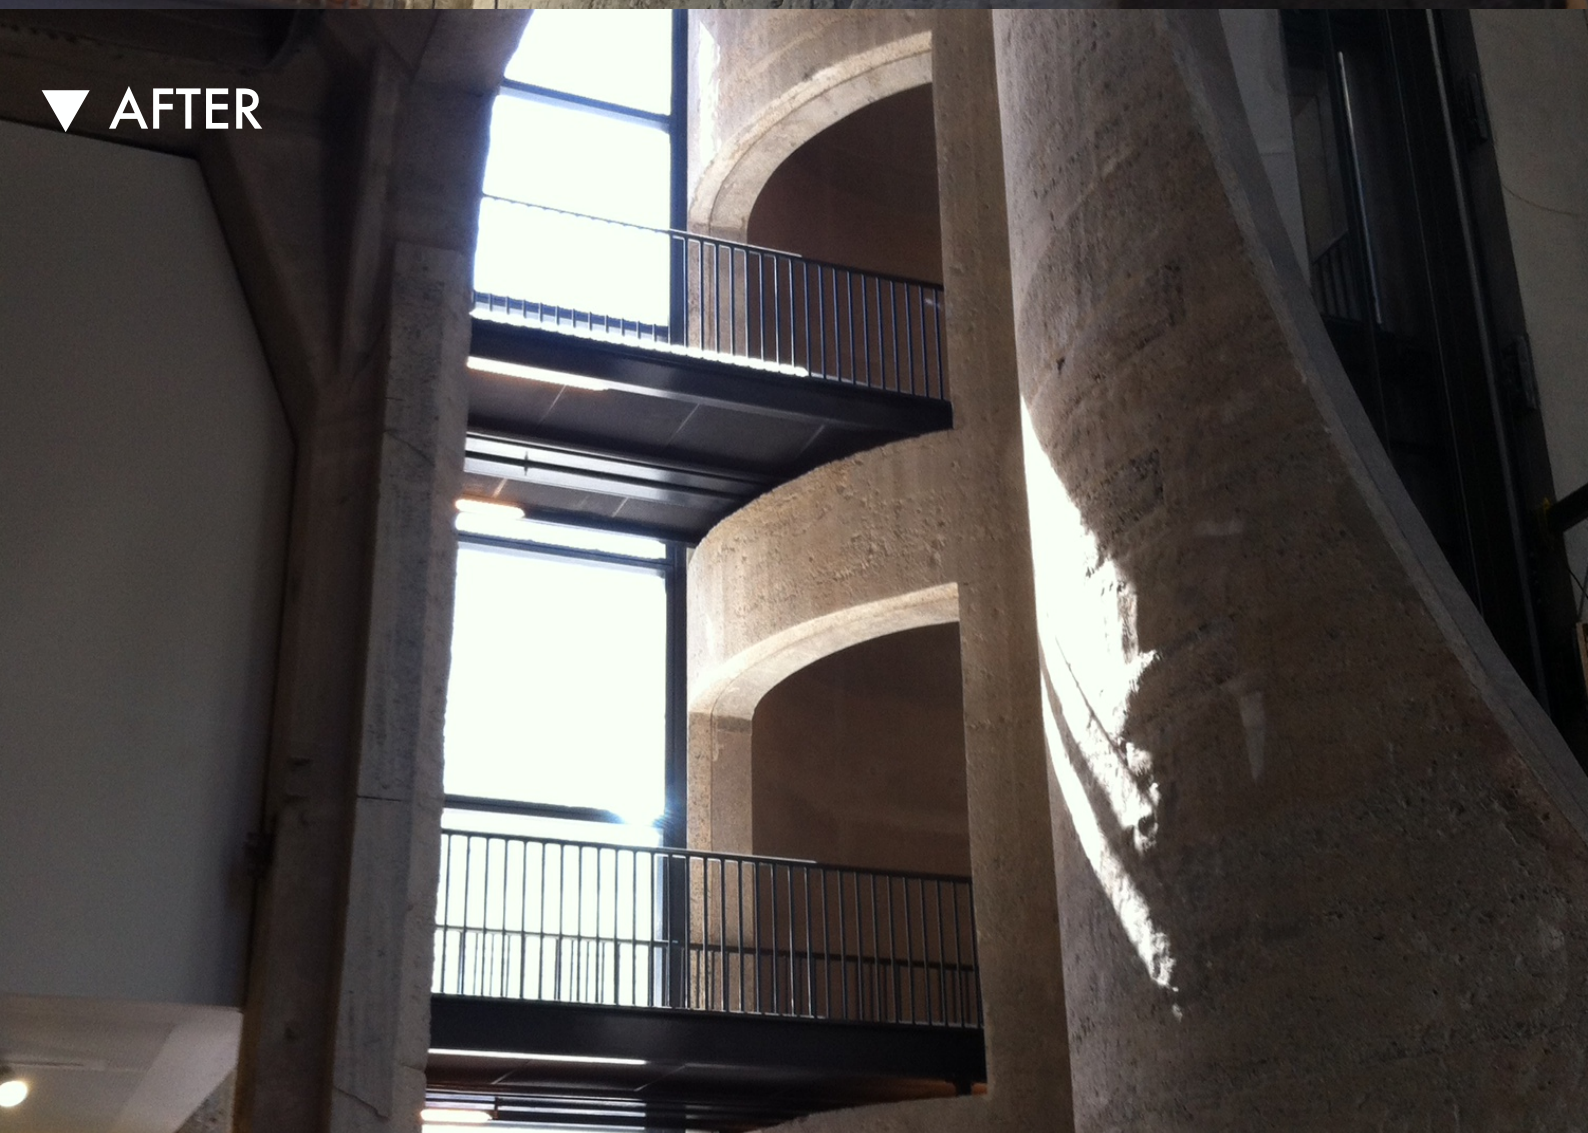
▲ BEFORE

▼ AFTER

"Ultimately, we developed a custom mixture of shades 9546 and 9550 in ratios ranging from 1:15 to 1:30.

For most surfaces, two coats of Concretal-Lasur were adequate. Only the most significant discolouration in the concrete required multiple coats by the painter."
